Carpenter Bees

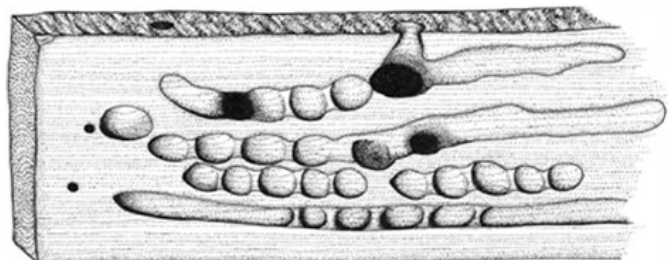
Carpenter bee nest burrows. Drawing by Erin L. Kimsey.

Females will begin construction of their nests after mating. The entrance hole to the nest starts inward (or upward) for a short distance and then follows the grain of the wood. Nest tunnels extend for 6-12 inches.

Carpenter bees may reuse the nests for several years, in which case the tunnels may extend for several feet. The females construct brood cells for their larvae within the tunnels. The nesting female will collect pollen and nectar and form a ball of this material, called bee bread. She will lay one egg on the ball and then seal off the brood cell with a “cement” of sawdust and saliva. She will continue in this fashion constructing additional brood cells in a row, typically 6 or 7 per nest.
